Bushfire Hazard Report

**13 Nielson Drive
Montrose**

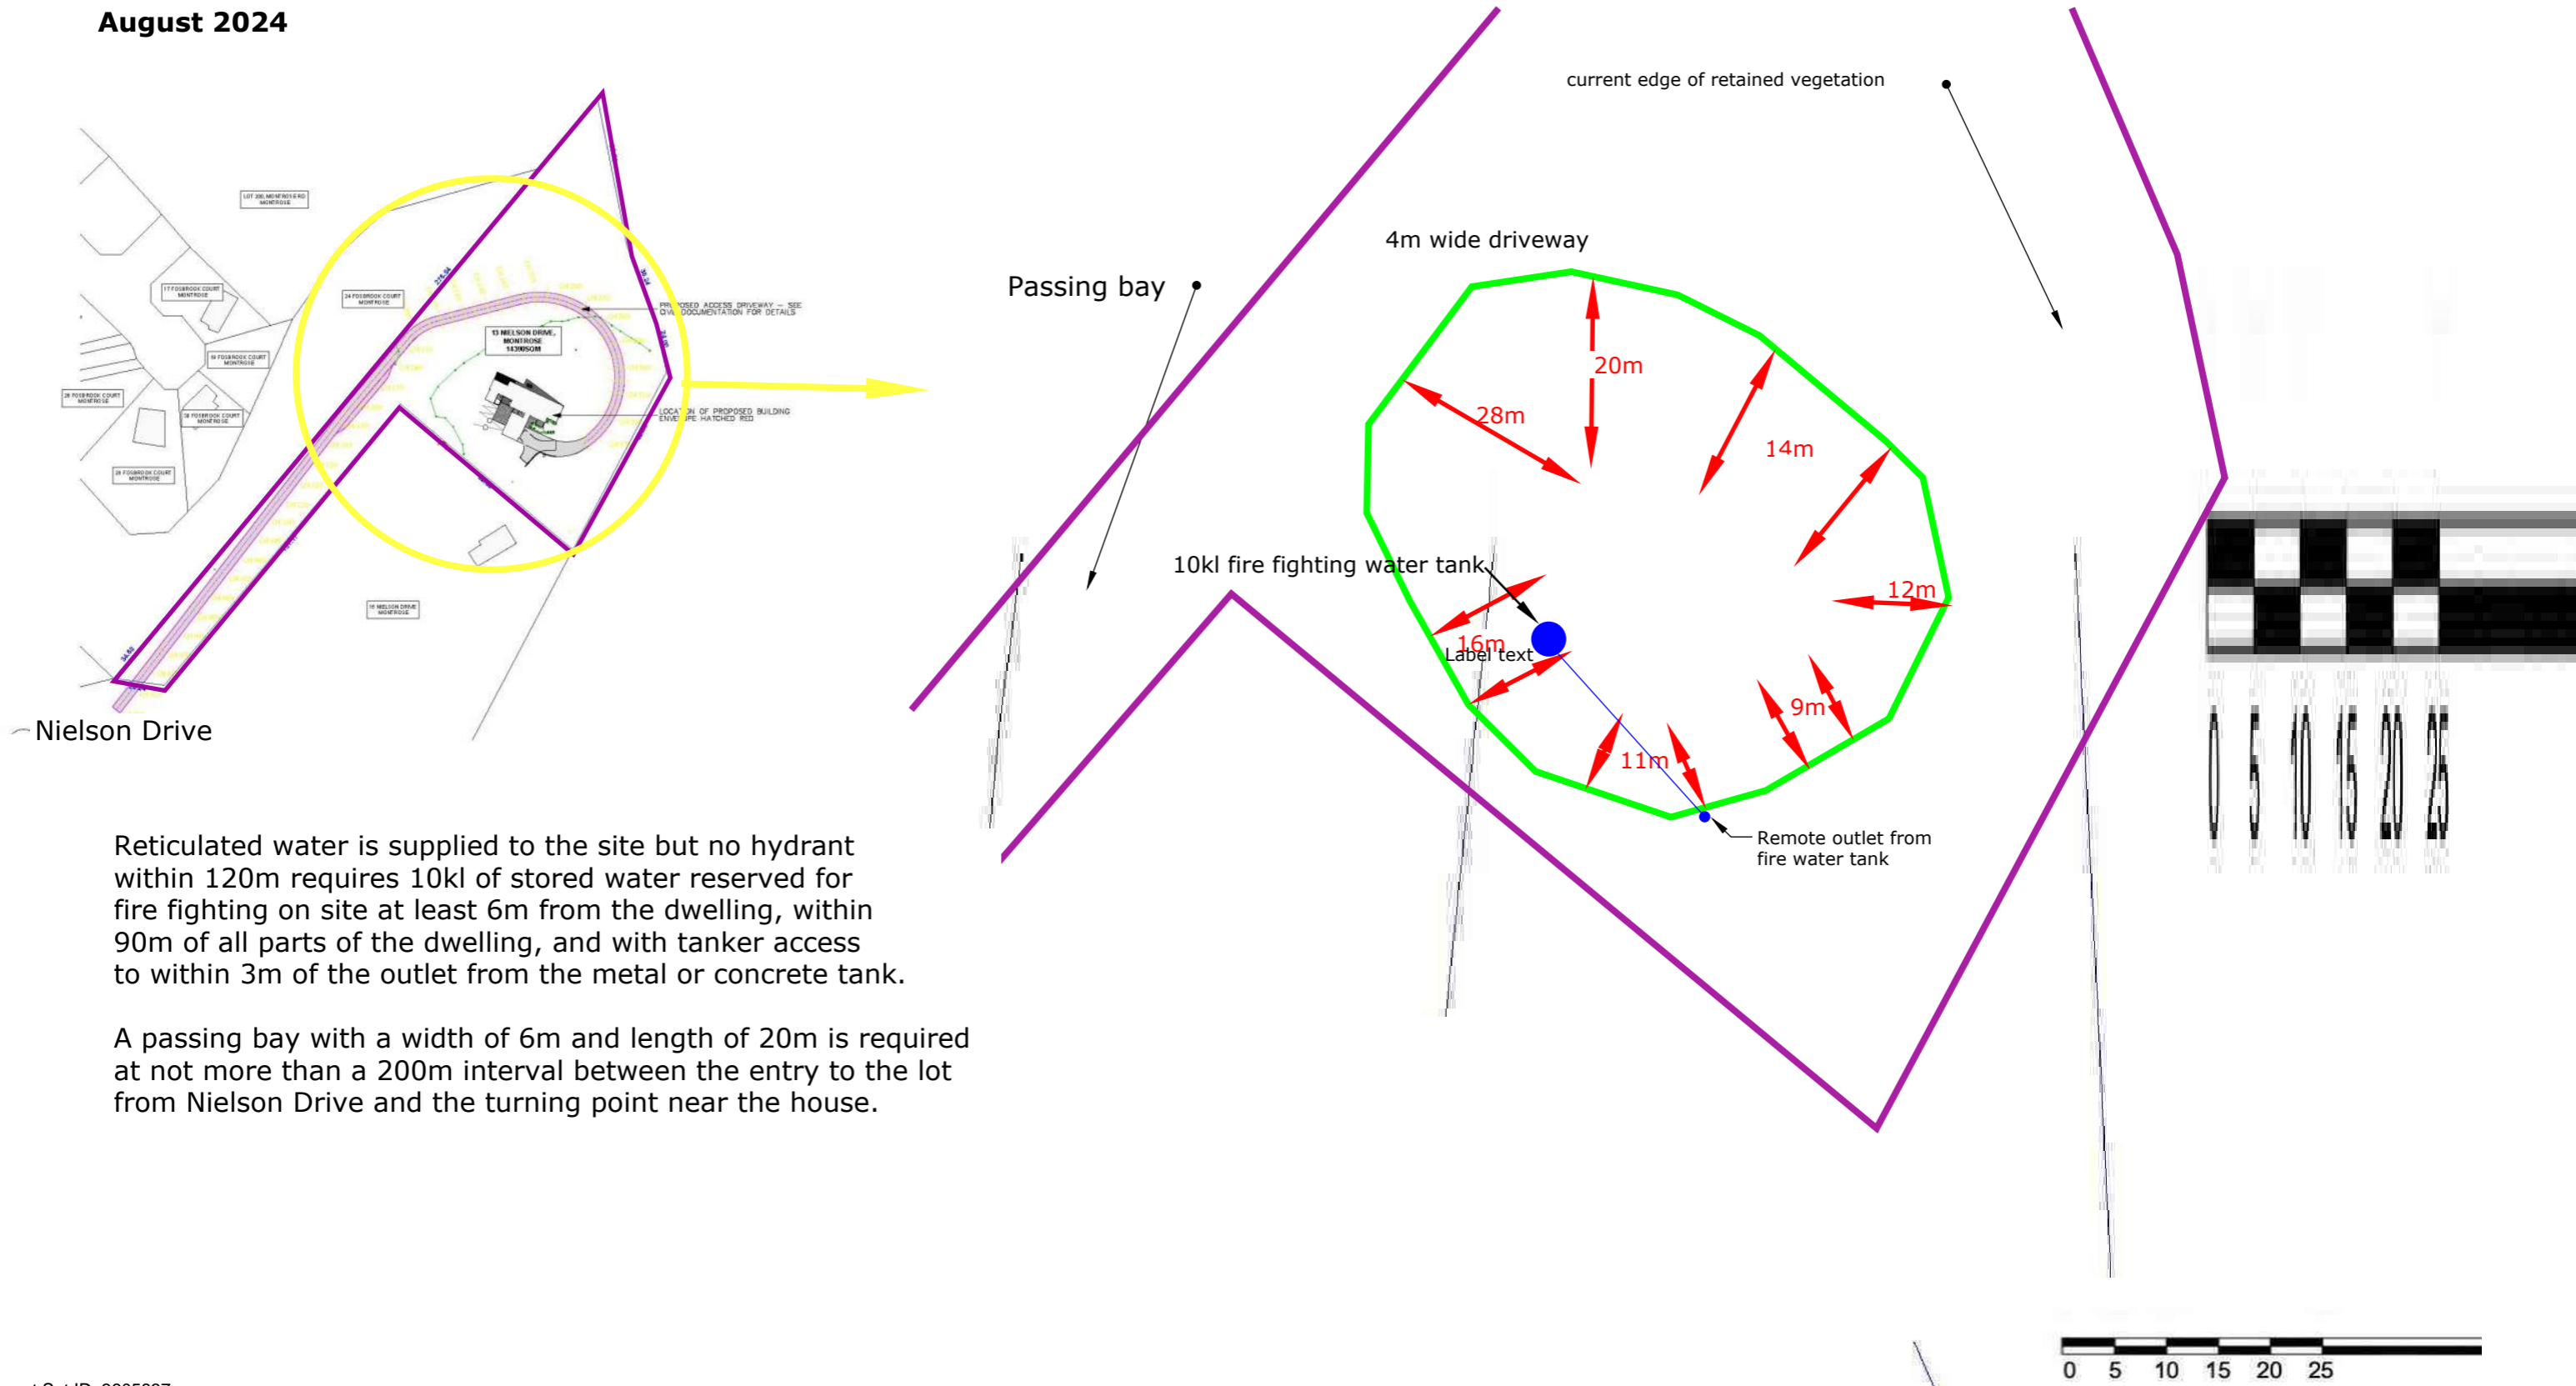
Reticulated water is supplied to the site but no hydrant within 120m requires 10kl of stored water reserved for fire fighting on site at least 6m from the dwelling, within 90m of all parts of the dwelling, and with tanker access to within 3m of the outlet from the metal or concrete tank.

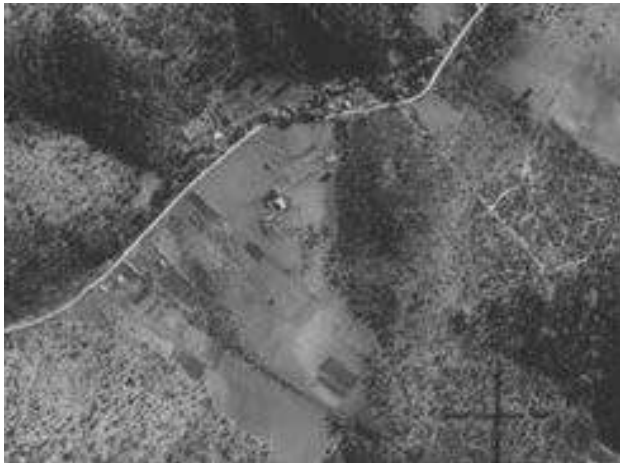
Figure 2-1 1947 Aerial photograph

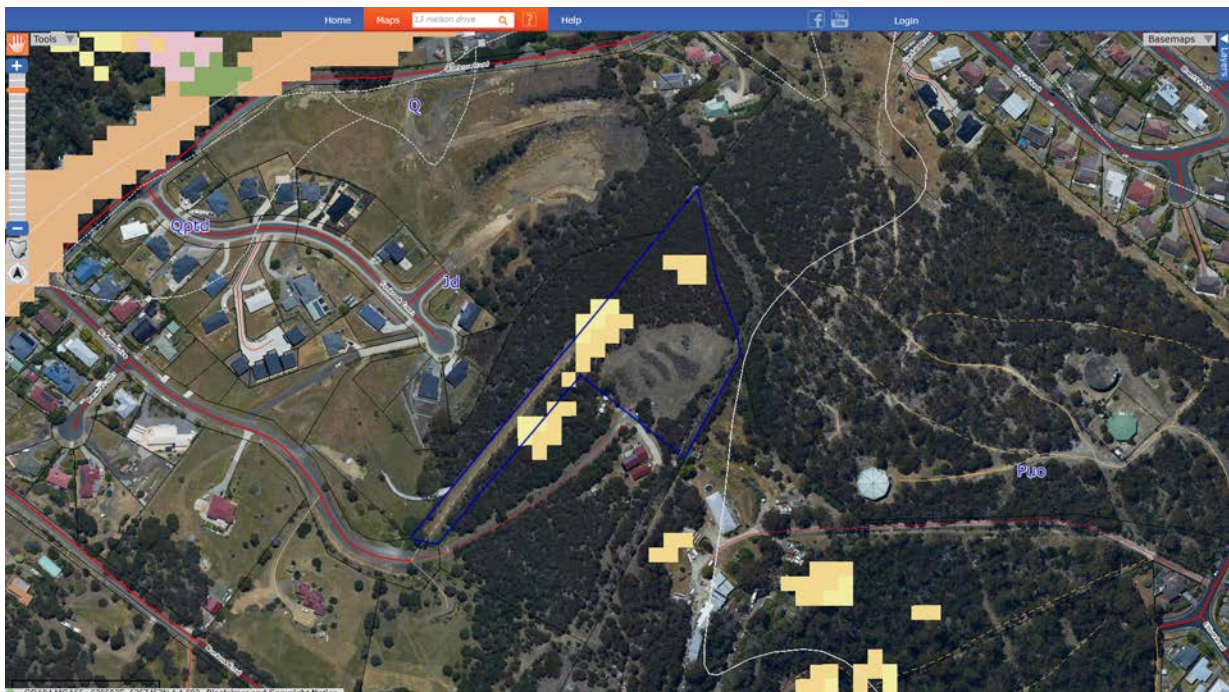
Figure 4 Rockfall susceptibility – pale yellow = lower bound runout area 30°, dark yellow area = source and upper bound runout area 34° (Source: LISTmap)

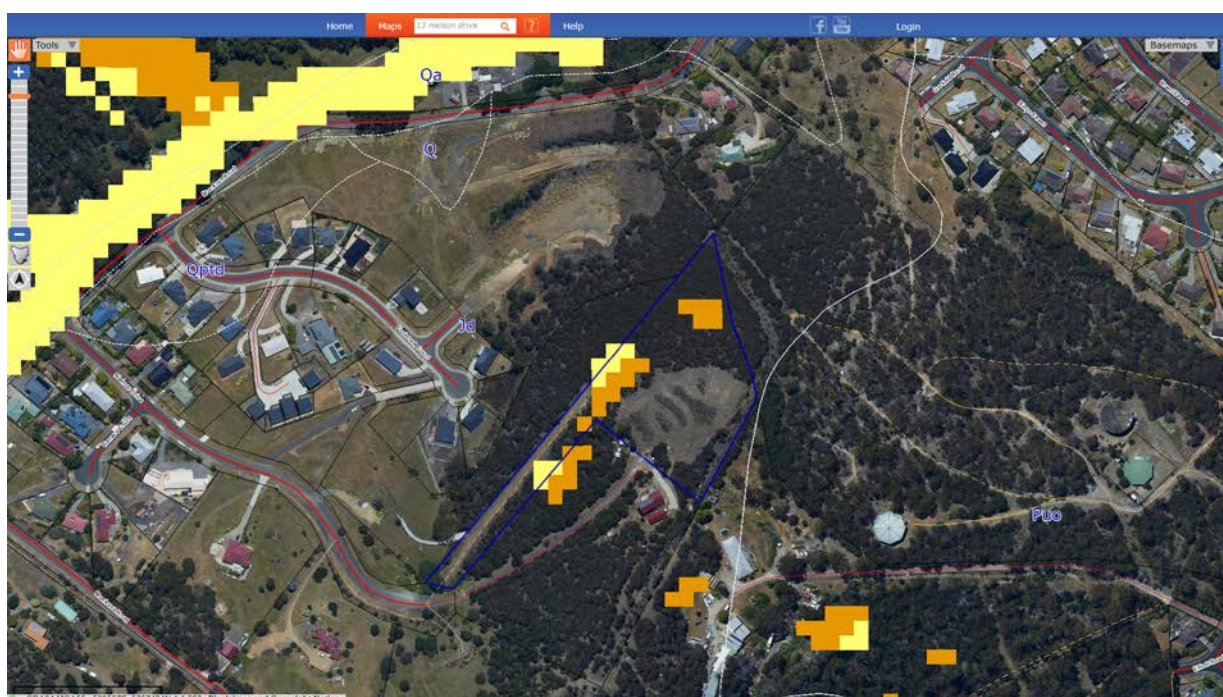
Figure 5 Landslide hazard bands – yellow area = Low risk, orange area = Medium risk (Source: LISTmap)

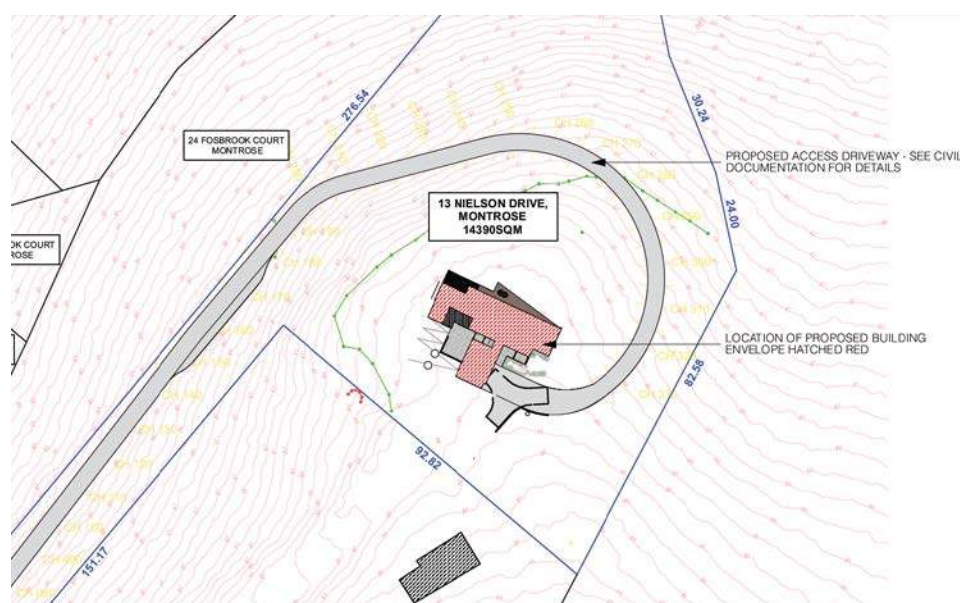
Figure 8 Proposed Layout, extract from IDW P/L drawing package

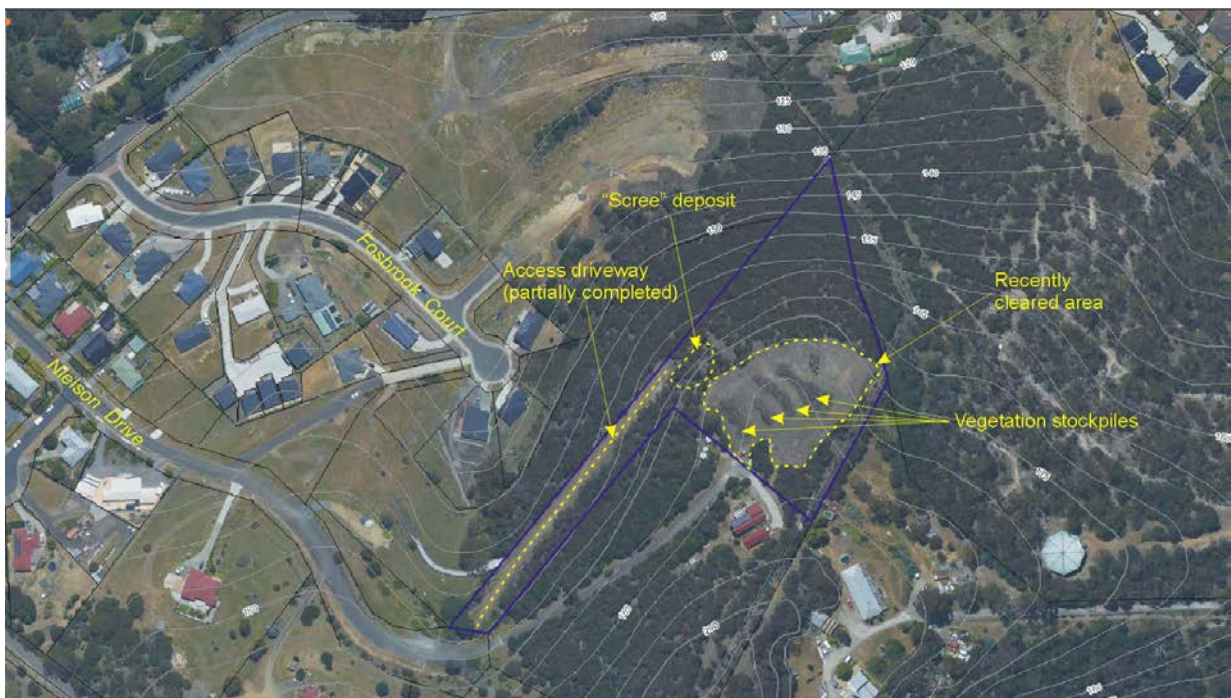
Figure 10 Site layout with salient features indicated (Source: LISTmap)

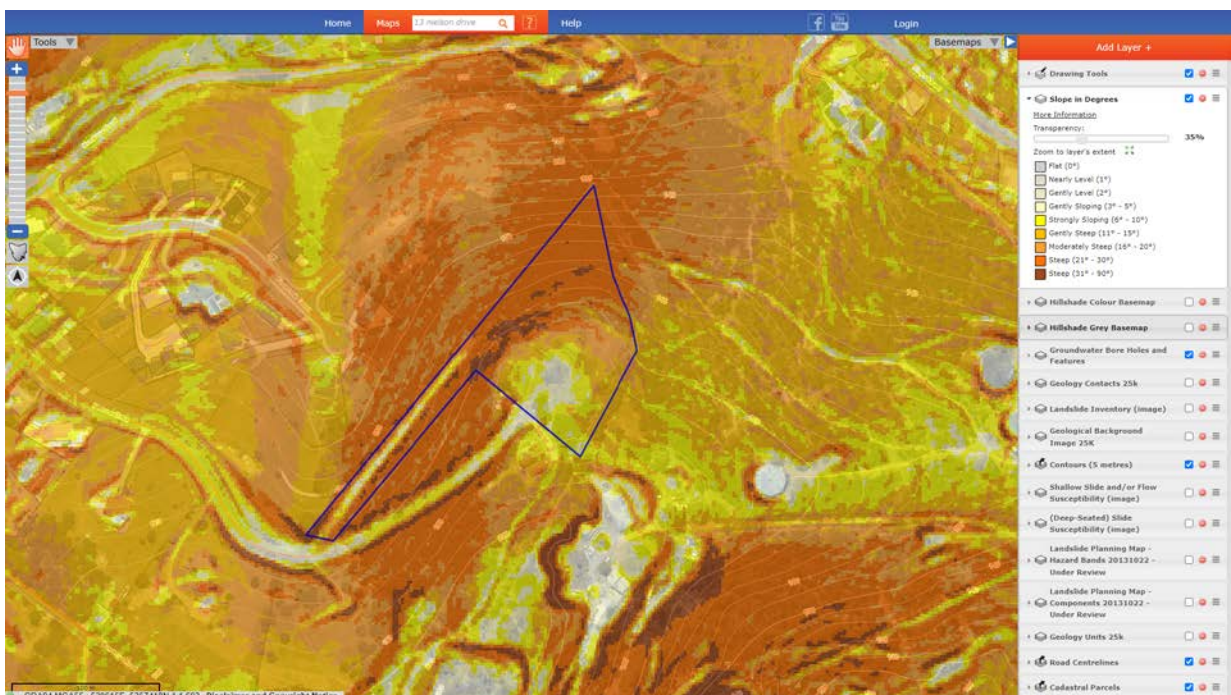
Figure 11 Site slope angles (Source: LISTmap)

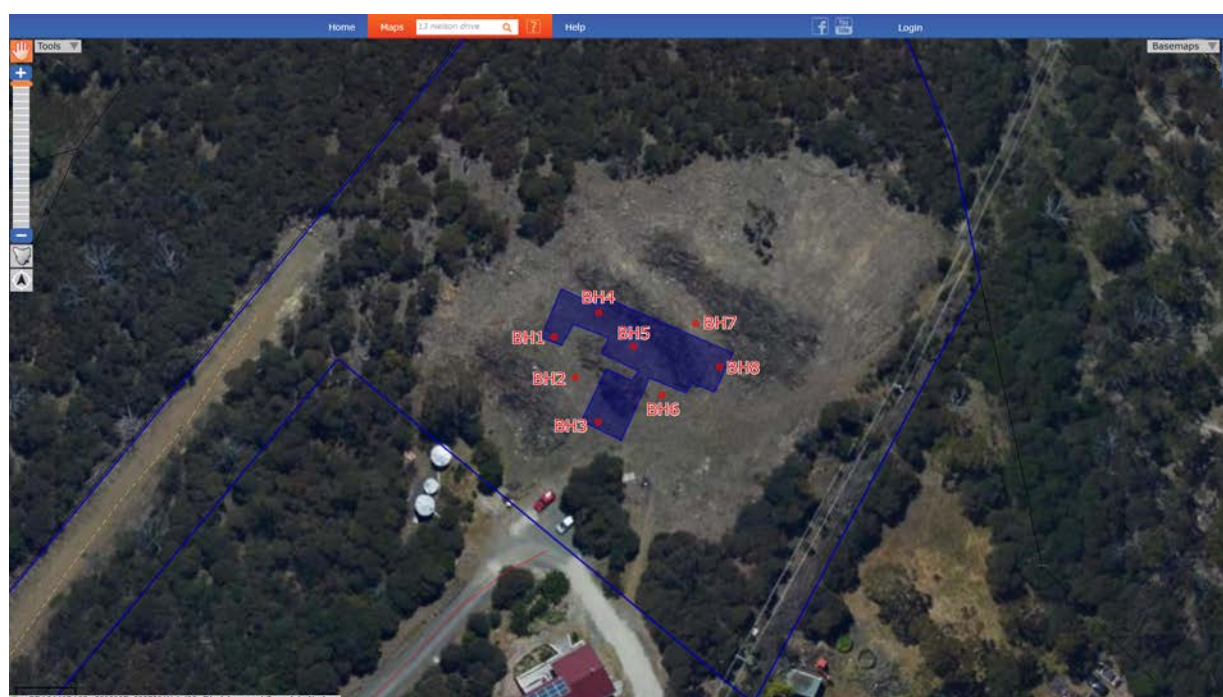
Figure 12 Borehole locations

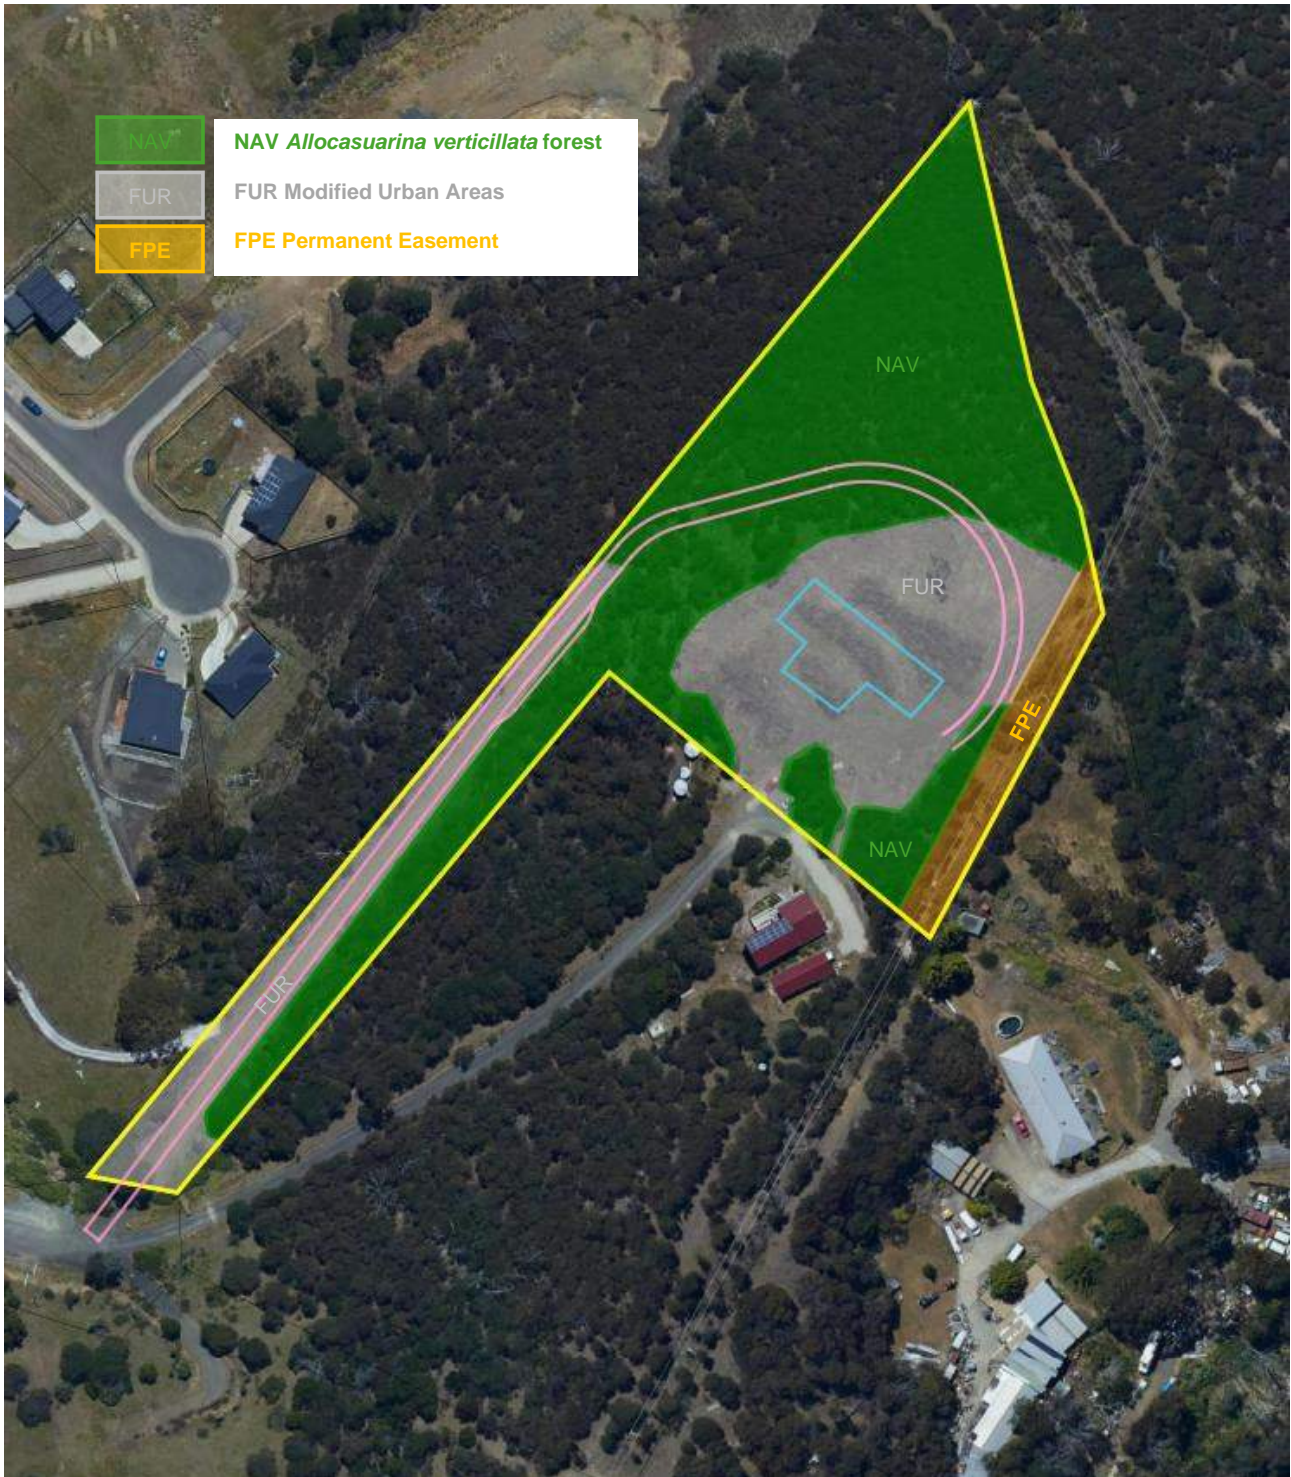
Figure 2: Vegetation units present in the project area

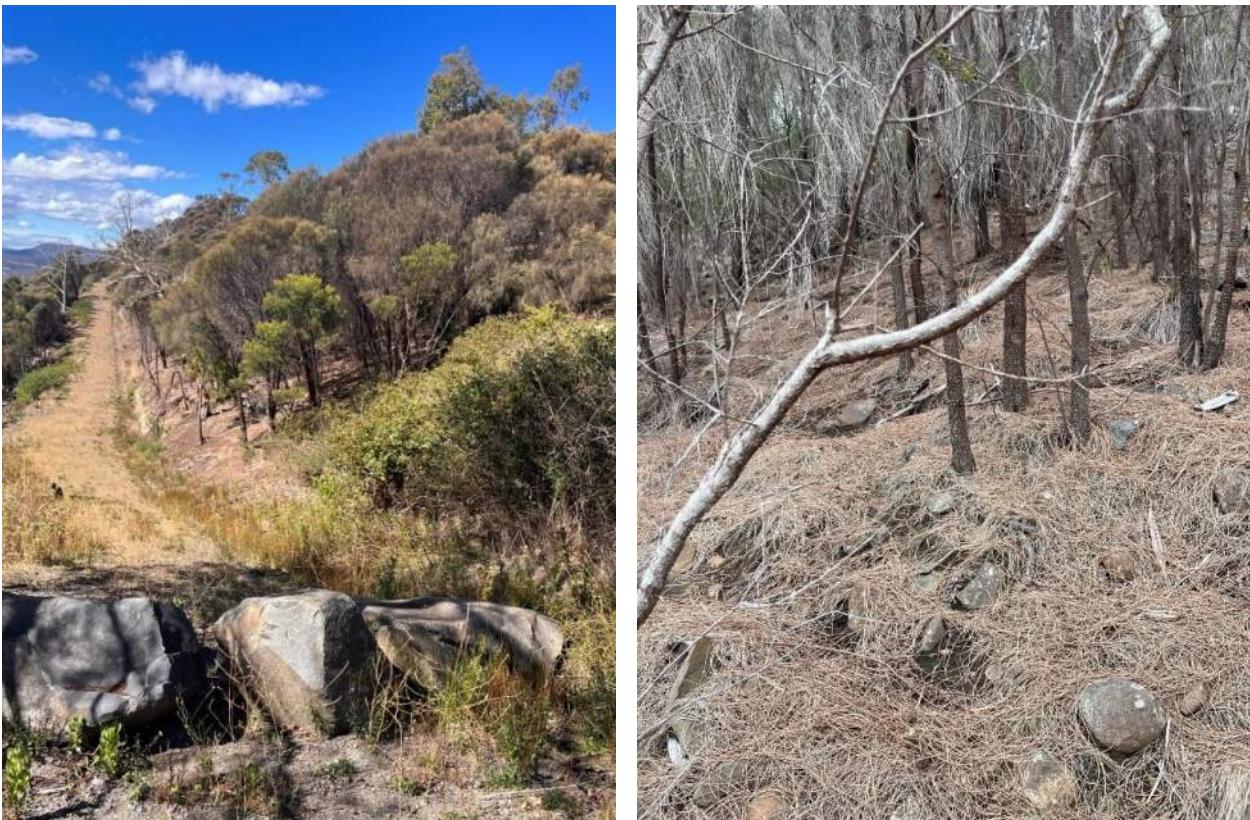
Figure 2: Vegetation present along existing formed section of access driveway (left); *Allocasuarina verticillata* forest with sparse understory and leaf litter ground cover with few ground species present (right).

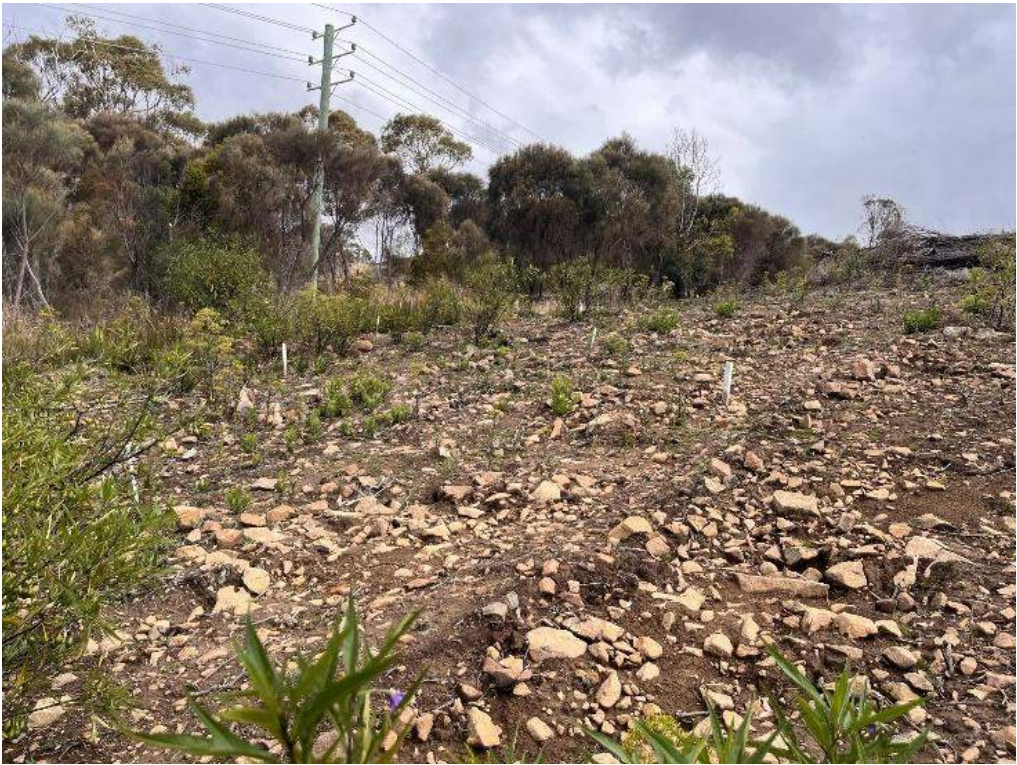
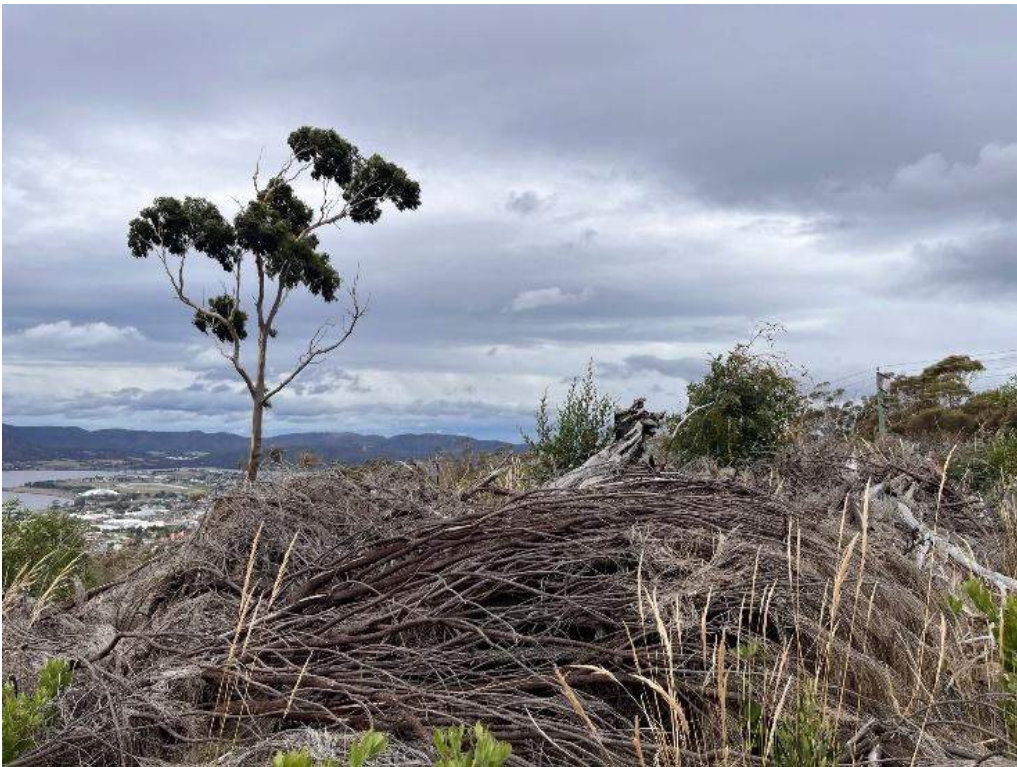
Figure 4: FUR Urban Areas unit within footprint of access driveway (top) and the centre of the project area with cleared vegetation piles, weeds and remnant *Eucalyptus viminalis* to be retained (bottom).
